**Flood Control Project Maintenance
Levee Inspections**

Fall 2010 Levee Maintenance Deficiency Summary Report

Reclamation District No. 2095 Paradise Cut

Levee Inspection Report By Mile - Fall 2010

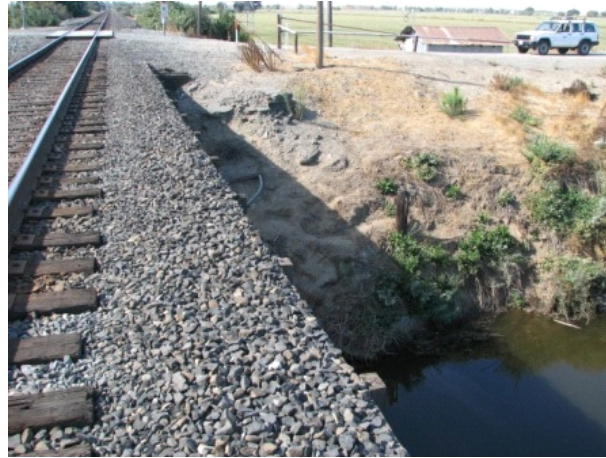
Levee Mile Report Line	9
Start Levee Mile	0.73
End Levee Mile	0.74
Location	Water Side
Category	Supplemental
Item	DWR Erosion Survey

Downstream view of site.

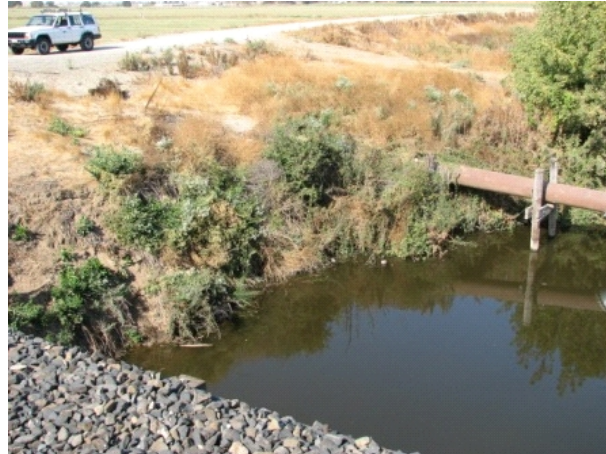
Levee Mile Report Line	9
Start Levee Mile	0.73
End Levee Mile	0.74
Location	Water Side
Category	Supplemental
Item	DWR Erosion Survey

Downstream view of site looking from the RxR crossing.

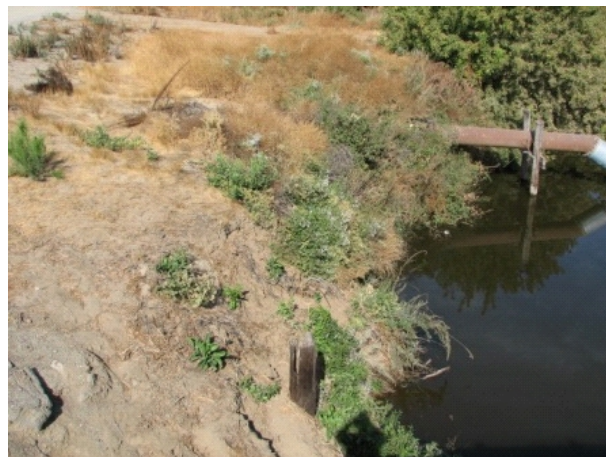
Levee Mile Report Line	9
Start Levee Mile	0.73
End Levee Mile	0.74
Location	Water Side
Category	Supplemental
Item	DWR Erosion Survey

Downstream view of the site. Note the siphon pipe and pump.

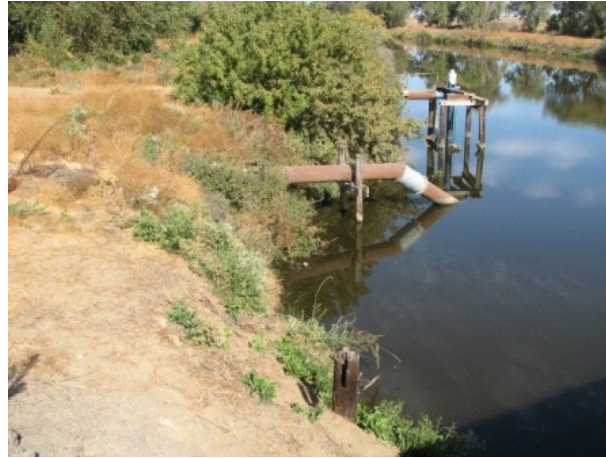
Levee Mile Report Line	9
Start Levee Mile	0.73
End Levee Mile	0.74
Location	Water Side
Category	Supplemental
Item	DWR Erosion Survey

Downstream view of the site.

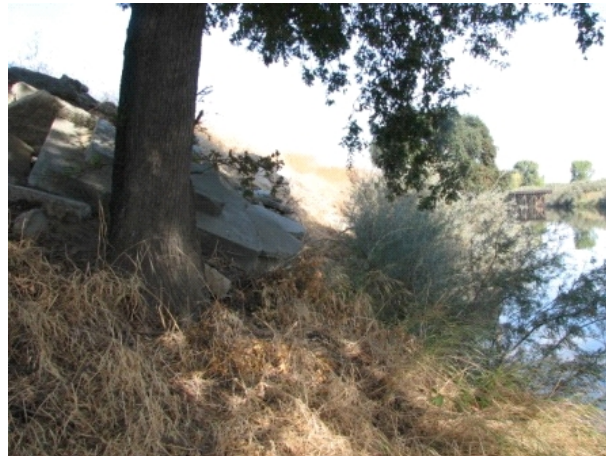
Levee Mile Report Line	11
Start Levee Mile	0.86
End Levee Mile	0.86
Location	Water Side
Category	Supplemental
Item	DWR Erosion Survey

10	0.75	0.75	Earthen Levee	Trim / Thin Trees	LS	C	Trim trees to at least five feet above ground level. Inspector Comments: Trees south of RR.	37.763048 ° -121.319090 °	37.763048 ° -121.319090 °	12
11	0.86	0.86	Supplemental	DWR Erosion Survey	WS	U	Inspector Comments: 09/22/2010: No significant changes observed. Sloughing of the existing rip rap possibly due to a combination of steep slope and undesirable flood conditions. 08/06/2010: Recommended as local maintenance issue, per CLRO. [2010 SiteID: RD2095U01RM6.88]	37.761960 ° -121.318140 °	37.761960 ° -121.318140 °	1 Y

Downstream view of site.

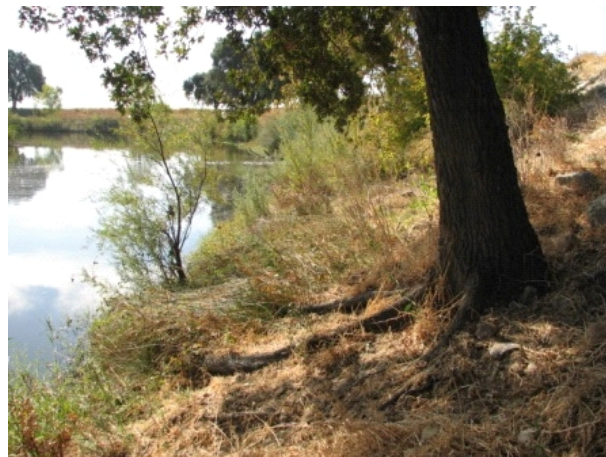
Levee Mile Report Line	11
Start Levee Mile	0.86
End Levee Mile	0.86
Location	Water Side
Category	Supplemental
Item	DWR Erosion Survey

Upstream view of site.

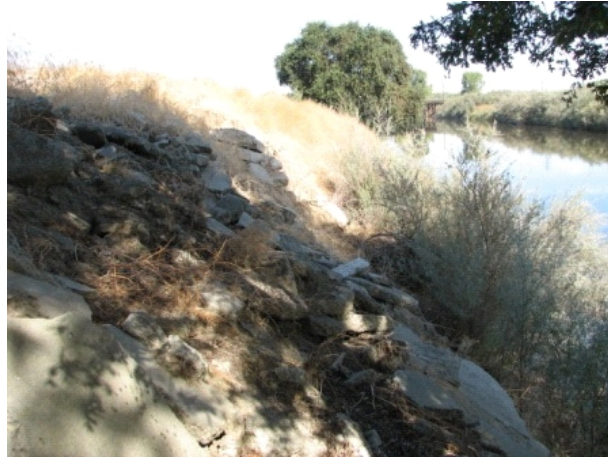
Levee Mile Report Line	11
Start Levee Mile	0.86
End Levee Mile	0.86
Location	Water Side
Category	Supplemental
Item	DWR Erosion Survey

Downstream view of site.

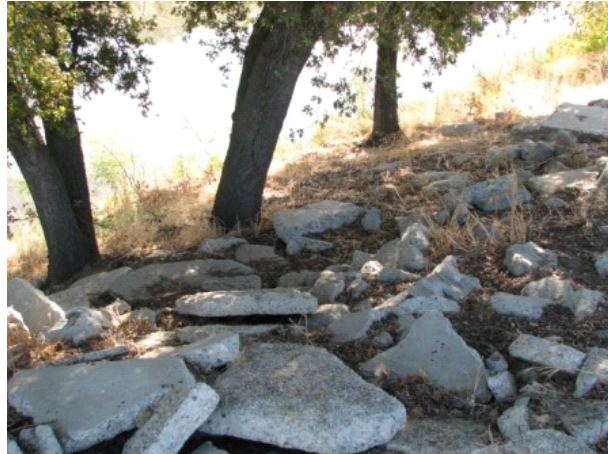
Levee Mile Report Line	11
Start Levee Mile	0.86
End Levee Mile	0.86
Location	Water Side
Category	Supplemental
Item	DWR Erosion Survey

Upstream view of site from upper slope.

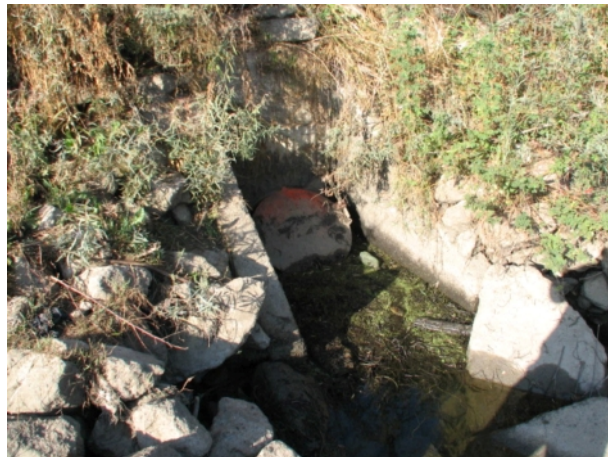
Levee Mile Report Line	13
Start Levee Mile	0.88
End Levee Mile	0.88
Location	Water Side
Category	Earthen Levee
Item	Encroachments

Gravity drainage outlet flapgate blocked by debris.

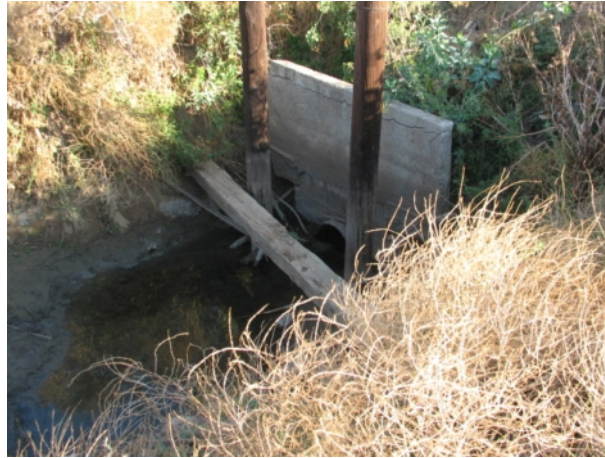
Levee Mile Report Line	13
Start Levee Mile	0.88
End Levee Mile	0.88
Location	Water Side
Category	Earthen Levee
Item	Encroachments

Gravity drain inlet.

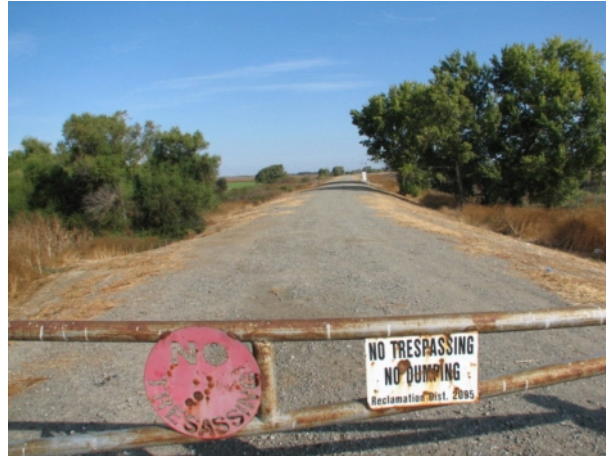
Levee Mile Report Line	1
Start Levee Mile	0.00
End Levee Mile	2.75
Location	Land Side
Category	Earthen Levee
Item	Vegetation

LMR No.	Levee Mile		Category	Item	Location	Rating	Action/Comment	GPS Latitude/Longitude		Issue No.
	Start	End						Start	End	Photo
1	0.00	2.75	Earthen Levee	Vegetation	LS	A	Remove the wild growth other than native grasses from the levee slopes. Inspector Comments: Mowing has greatly improved access and visibility of levee slopes.	37.759174 ° -121.308511 °	37.726466 ° -121.299629 °	9 Y
2	0.17	0.31	Earthen Levee	Encroachments	LS	C	Agricultural tilling	37.757630 ° -121.306530 °	37.755663 ° -121.305733 °	5
3	0.45	0.45	Earthen Levee	Slope Stability	LS	W	Repair the levee slope damaged by vehicle traffic and prevent access where possible. Inspector Comments: 4 wheeler traffic on levee slope. Straw placed to minimize erosion.	37.753697 ° -121.305812 °	37.753697 ° -121.305812 °	7
4	0.47	0.58	Earthen Levee	Encroachments	LS	C	Agricultural tilling	37.753452 ° -121.305500 °	37.752038 ° -121.304512 °	8
5	0.62	0.62	Earthen Levee	Vegetation	LS	M	Elderberries are blocking visibility and flood fight capability.	37.751668 ° -121.304302 °	37.751668 ° -121.304302 °	6

Recent mowing has greatly improved access and visibility down levee slopes.

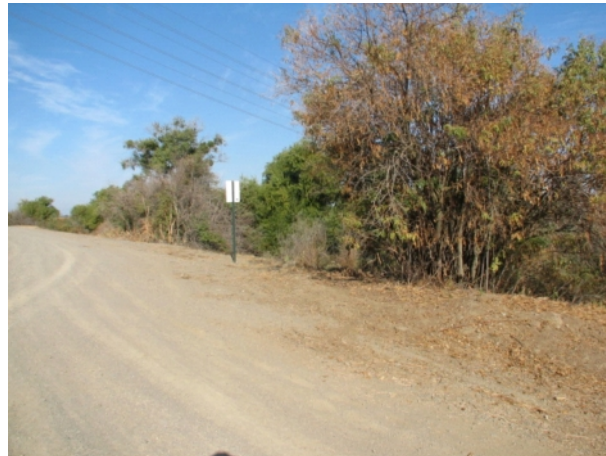
Levee Mile Report Line	9
Start Levee Mile	1.01
End Levee Mile	1.01
Location	Water Side
Category	Earthen Levee
Item	Vegetation

Elderberry blocks visibility of levee slope.

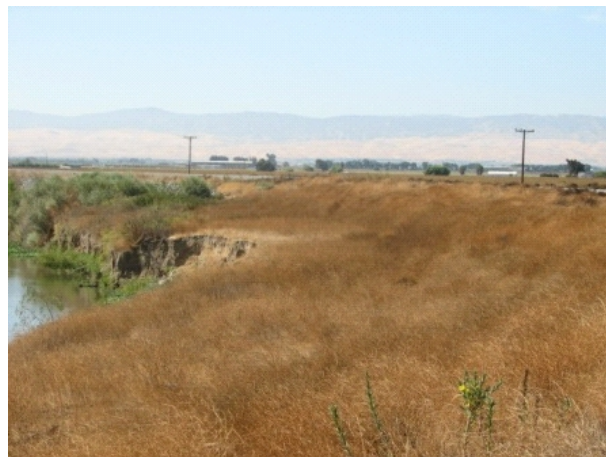
Levee Mile Report Line	17
Start Levee Mile	1.77
End Levee Mile	1.80
Location	Water Side
Category	Supplemental
Item	DWR Erosion Survey

Upstream view of the site from the levee crown.
Note the dense vegetation on the berm.

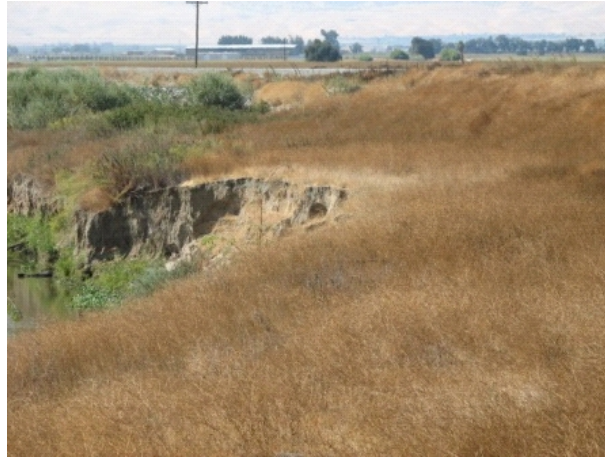
Levee Mile Report Line	17
Start Levee Mile	1.77
End Levee Mile	1.80
Location	Water Side
Category	Supplemental
Item	DWR Erosion Survey

Upstream view of the site.

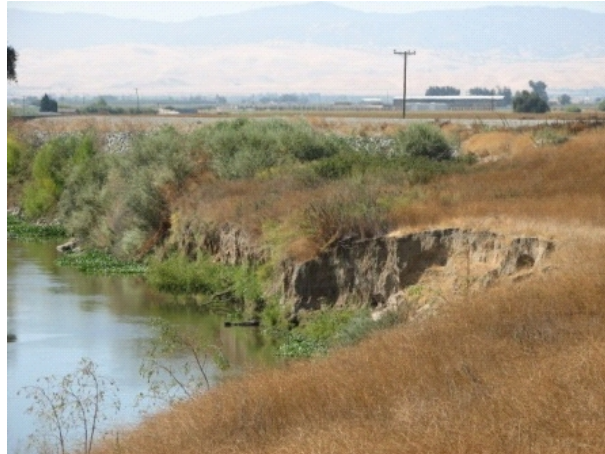
Levee Mile Report Line	17
Start Levee Mile	1.77
End Levee Mile	1.80
Location	Water Side
Category	Supplemental
Item	DWR Erosion Survey

Upstream view of the site.

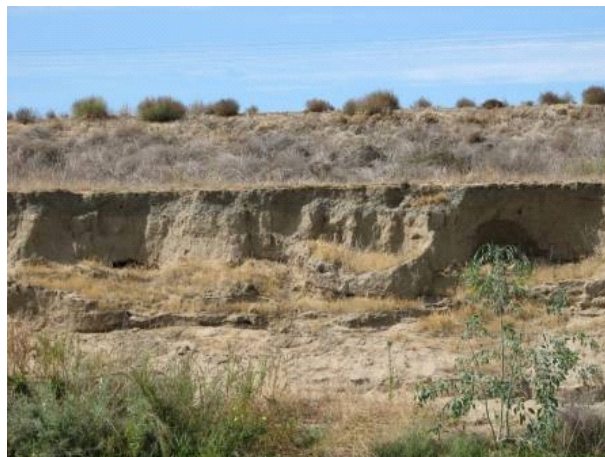
Levee Mile Report Line	17
Start Levee Mile	1.77
End Levee Mile	1.80
Location	Water Side
Category	Supplemental
Item	DWR Erosion Survey

Photo taken in 2009. Front view of the erosion from a boat.

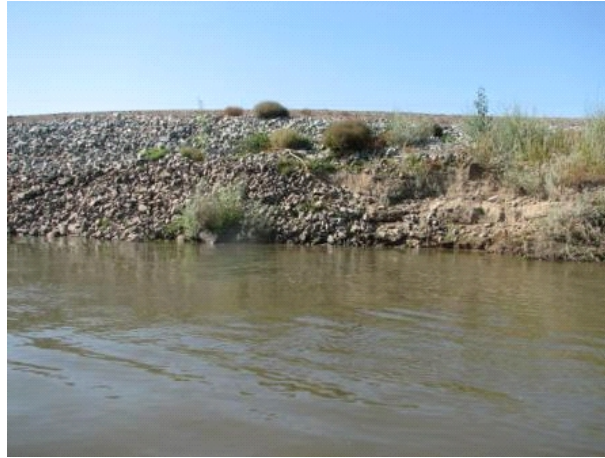
Levee Mile Report Line	18
Start Levee Mile	1.85
End Levee Mile	1.89
Location	Water Side
Category	Supplemental
Item	DWR Erosion Survey

Direct view of erosion. Photo taken in 2009.

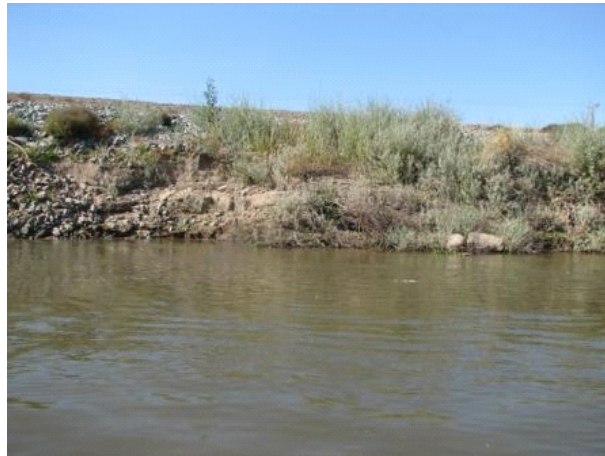
Levee Mile Report Line	18
Start Levee Mile	1.85
End Levee Mile	1.89
Location	Water Side
Category	Supplemental
Item	DWR Erosion Survey

Downstream view of erosion. Note emergent vegetation on the extended berm. Photo taken in 2009.

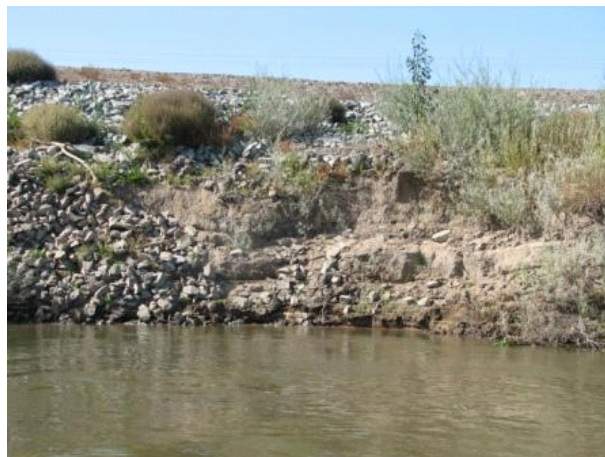
Levee Mile Report Line	18
Start Levee Mile	1.85
End Levee Mile	1.89
Location	Water Side
Category	Supplemental
Item	DWR Erosion Survey

Direct view of erosion. Erosion is occurring at the bank, just below the existing rip rap. Photo taken in 2009.

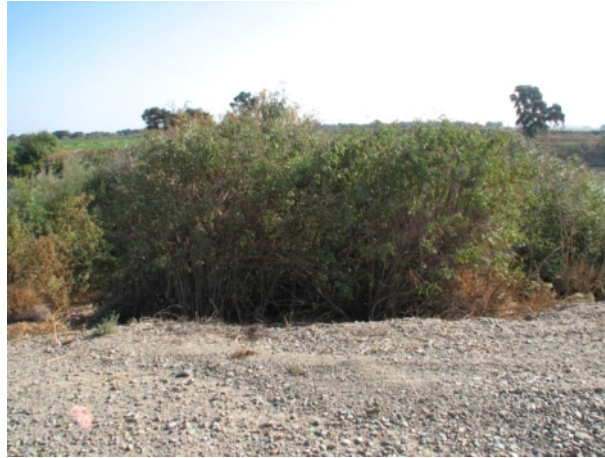
Levee Mile Report Line	21
Start Levee Mile	2.14
End Levee Mile	2.14
Location	Water Side
Category	Earthen Levee
Item	Vegetation

Vegetation on waterside slope obstructs access and visibility.
